## Technical Note TN-724

# Power Problems with “-2XX” 66-88MHz T2000s

4<sup>th</sup> November 2002

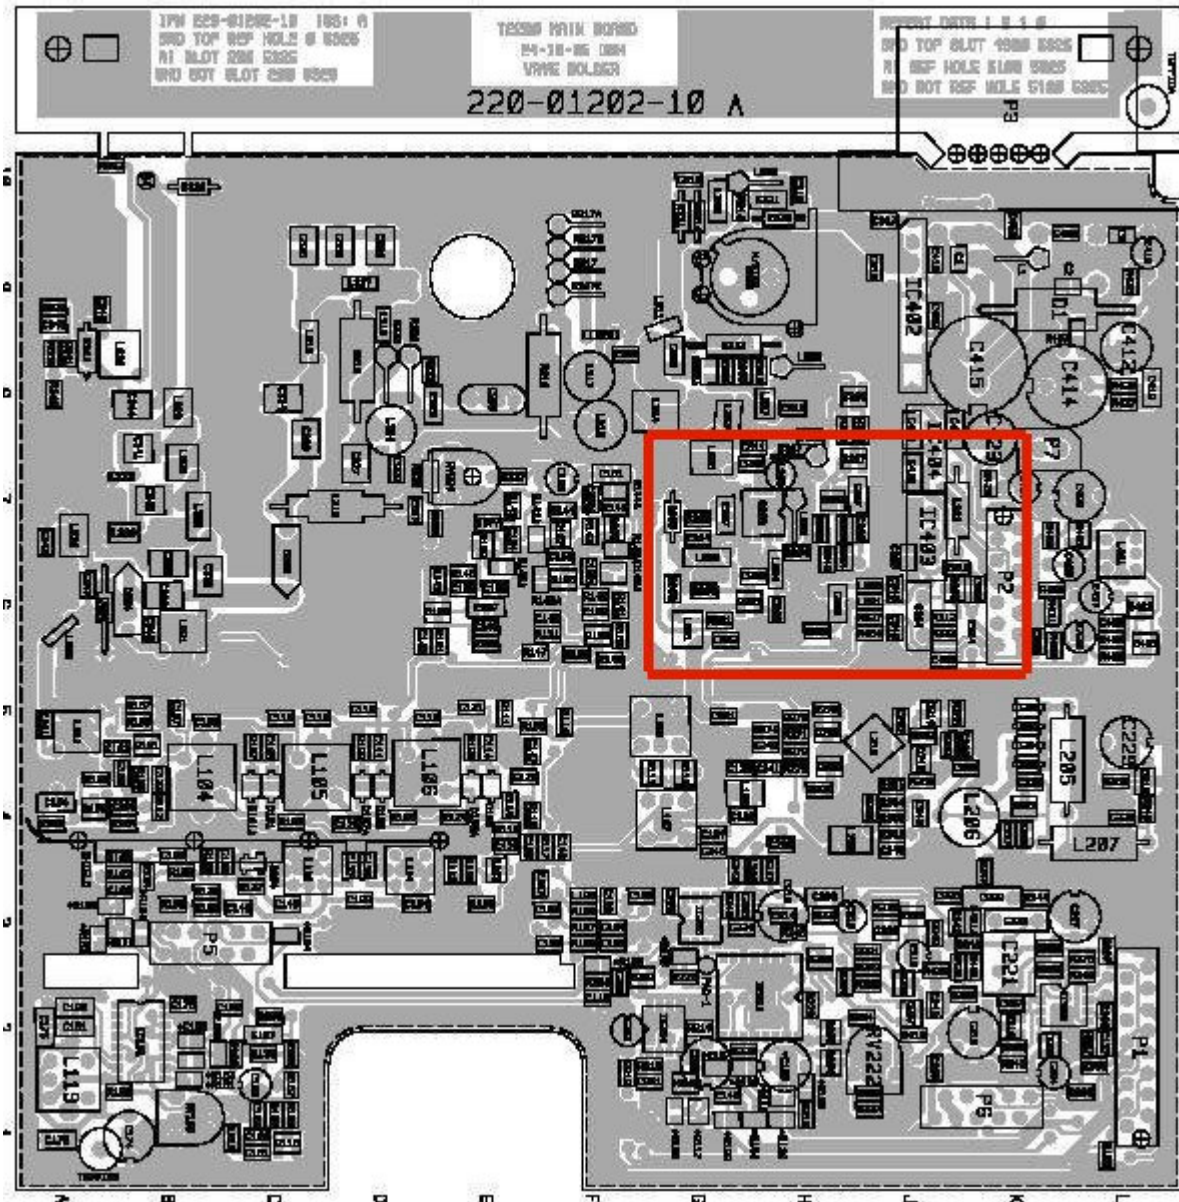
It has been found that the T2000 66MHz to 88MHz RF boards that use the Microsemi MRF3866 transistor may have a power sag problem causing the radios, after a period of operation, to reduce power output eventually to zero watts. This only happens on radios operating above 80MHz.

The illustrations below and on the next page show the components and their locations.

See the next page for a close up view of the indicated section

- **Changing Q302 from 000-10386-60 (MRF3866) to 000-10144-27 (MSMRF4427)**
- **Changing R307 from 030-53330-20 (330E) to 030-53120-20 (120E)**
- **Changing R312 from 036-13680-00 (680E) to 036-13390-00 (390E)**
- **Changing C305 from 015-23120-01 (120P) to 015-23180-01 (180P)**
- **Changing L304 from 052-56135-25 (2.5T/3.5MM) to 052-08132-15 (1.5T/3.2MM)**
- **Changing L302 from 052-56145-35 (3.5T/4.5MM) to 052-08145-25 (2.5T/4.5MM)**
