**Identifying Damaged
Tait Orca TOPA-AN-202
Antennas**

15 April 2003

This Technical Note provides visual indicators to identify TOPA-AN-202 antennas that have failed in the field.

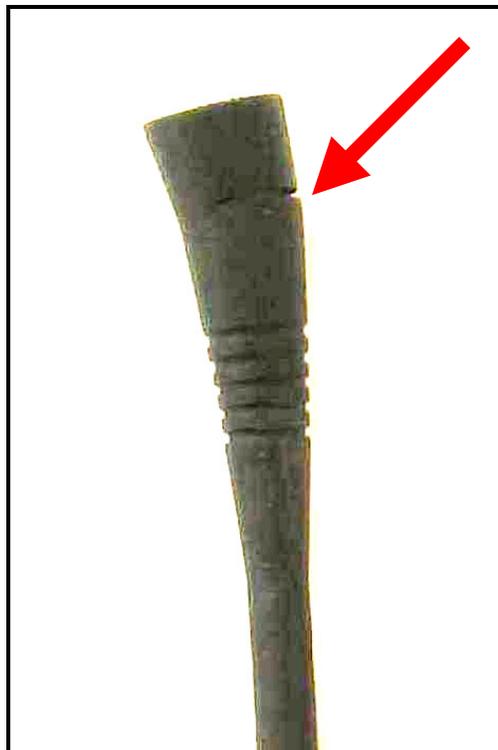
Figure 1

The existing Orca ¼ wave UHF whip antenna, TOPA-AN-202, could fail to radiate RF signal if the antenna is damaged.. The failure to radiate is attributed to the antenna's centre pin breaking. Quite often a break of the antenna pin will allow the pin to fall out of the antenna when it is removed from the radio.

Usually the break is obvious as seen in **Figure 1** below.

Related Documents	E-mail updates 1 to 6. Focus calls: 5421, 5692 and 5831. Warranty Remedy: WR-015
Solution	All TOPA-AN-202 antennas that fail should be replaced with the TOPA-AN-212 antenna by implementing Warranty Remedy WR-015. Note: If there are 'J' and 'K' band users with failed TOPA-AN-202 antennas these should be replaced with the TOPA-AN-204 or TOPA-AN-205 respectively.
Compliance	None.
CSO Instruction	Please inform all technical, sales, logistics staff and accredited dealers of the how to recognise failed antennas.

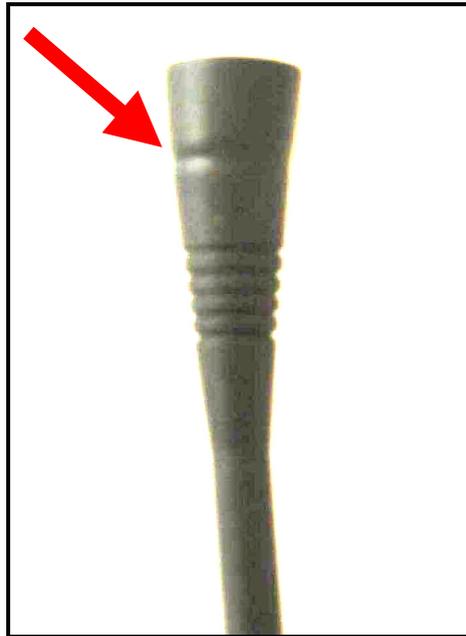
Figure 2

However the antenna may only show a 'rib' about 10mm from the base as shown in **Figure 2**. This antenna has a broken centre pin. This can be verified by measuring from the pin to the top of the antenna whip with an ohmmeter. This antenna is open circuit, and should be replaced.
