TECHNICAL NOTE TN-1185

Addendum to TN-538A (Improving MRF555 and MRF630 Transistor Reliability)

14 June 2006

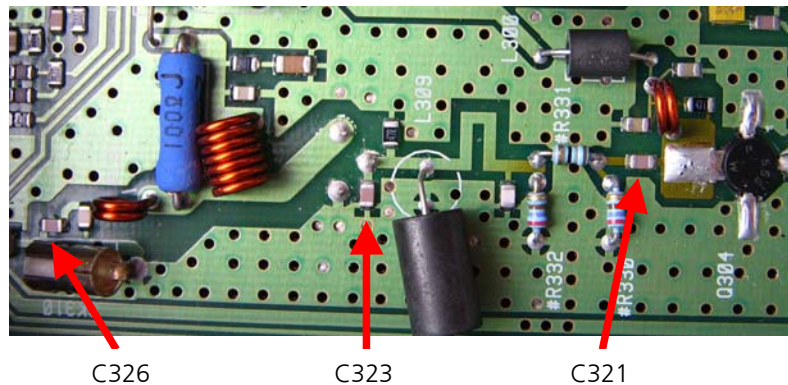
This Technical Note is an addition to the procedure outlined in TN-538A and should be performed whenever the TN538A modifications are done. In Series I & II exciters there are 3 capacitors that have shown to be weak points, and these are worth replacing when performing TN-538A to prevent future failures.

Figure 1. Location of caps in Series II.

Capacitors to be replaced are C321, C323, & C321 as shown in Figure 1.

C321: 015-22220-01 (CAP cer 22p NPO 50V 5% 0805)

C323: 015-22330-01 (CAP cer 33p NPO 50V 5% 0805)

C326: 015-21470-01 (CAP cer 4p7 ±.25pF 50V 0805)

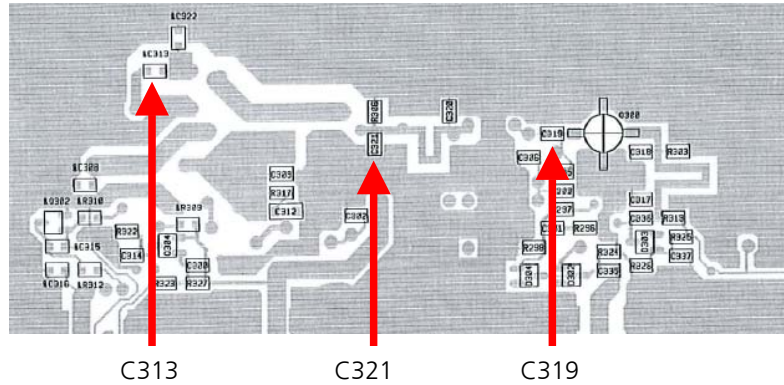
Figure 2. Location of caps in Series I (Drive Amp cavity)

Capacitors to be replaced are C313, C319, & C321 as shown in Figure 2.

C313 & C319: 015-22220-01 (CAP cer 22p NPO 50V 5% 0805)
C321: 015-22330-01 (CAP cer 33p NPO 50V 5% 0805)
