Technical Note TN-800

Tait Orca 5010, 5015, 5020  
Firmware Upgrade to 2.11 &  
TOP-CPA Upgrade to 3.8.1

19 September 2003

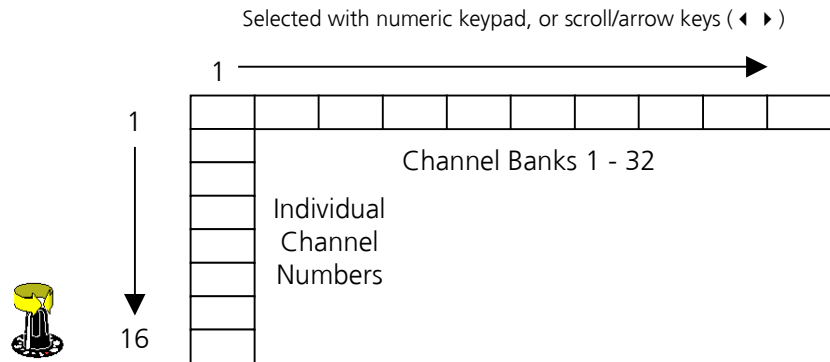
➤ Banking – Channel Selection

When selected, the channel rotary selector of the radio will correspond to the channel to be selected

from within the currently active channel bank (block). The numeric keypad will handle changing of channel banks. Also the scroll/arrow keys (◀ ▶) scroll from channel bank to channel bank, a press of the Enter (✓) key confirms selection of a specific channel bank.

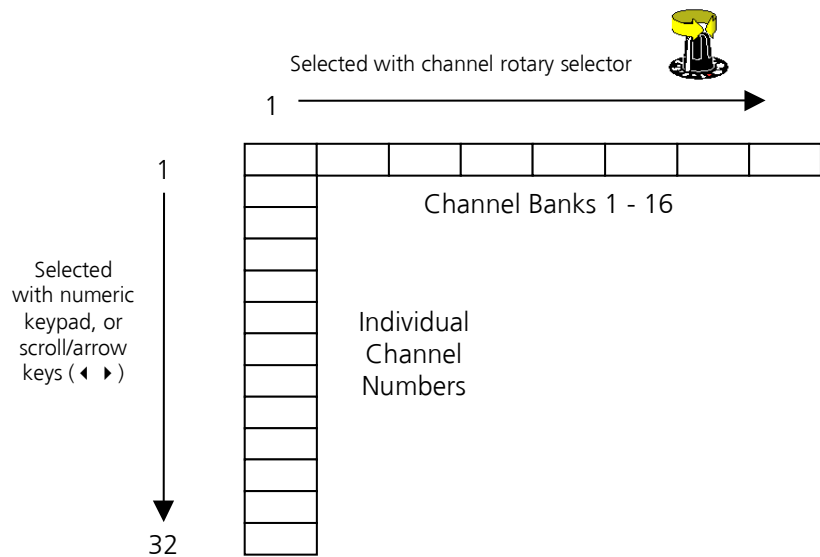
➤ Banking – Bank Selection

When selected, the channel rotary selector of the radio will correspond to the channel bank (block) to be selected.

The numeric keypad will handle the changing of channels. The scroll/arrow keys (◀ ▶) scroll from channel to channel within the active channel bank.
