## TECHNICAL NOTE TN-1025

### Reciter May Reset when Calibrating VCO Lock Range

27 May 2005

All Reciters prior to serial number 18009103.

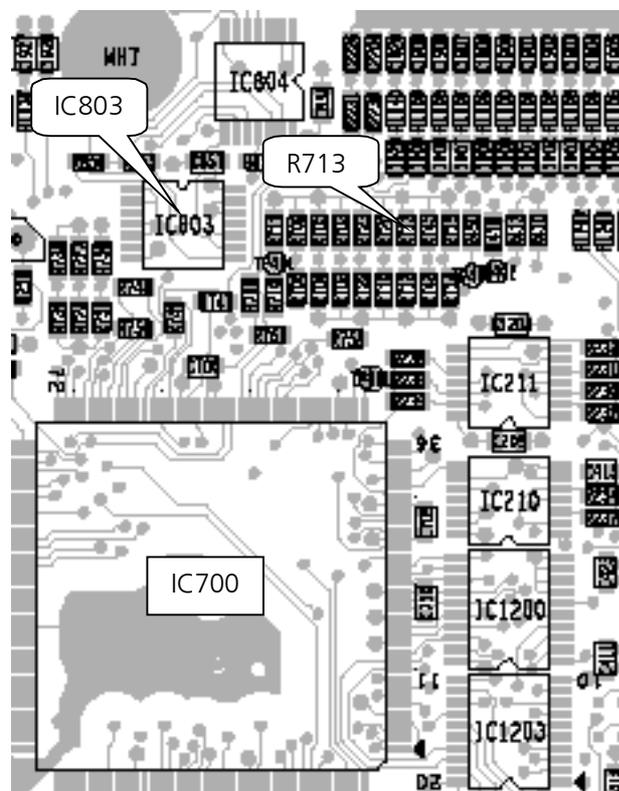
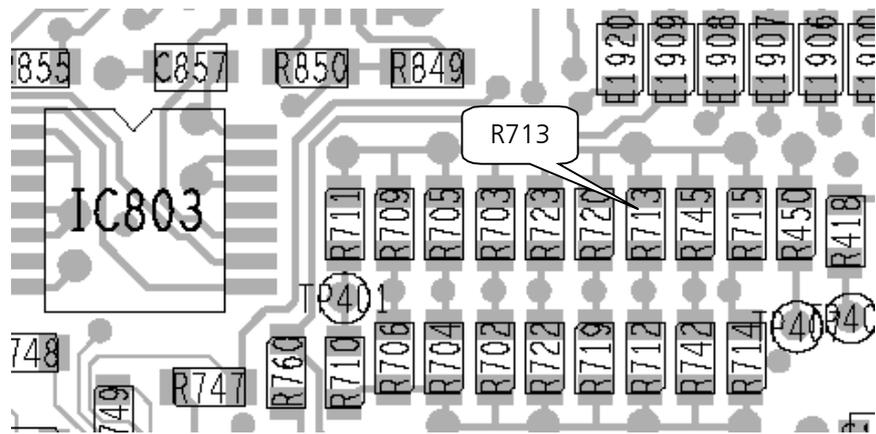
A reciter reset issue has been noted in manufacturing. If this is an issue with any reciter in the field, it will be seen when adjusting the VCO lock range with the Calibration Kit software. The long-term fix for the problem involves adding a D flip-flop when the digital board is re-designed. In the mean time, a simple fix for any reciters that show this problem while the VCO is being adjusted is to add a 10pF capacitor (IPN 018-12100-10) in parallel with R713.

R713 is located on the digital board near IC700. See the 2 pictures below. Fit a 10pF capacitor (IPN 018-12100-10) on top of R713.

This problem only occurs when the reciter is used with the Calibration Kit software. If a customer has a problem with their reciter, it is recommended that this modification be done in the CSO workshop unless the customer is known to have the required skill and equipment to affect this modification.
