# TECHNICAL NOTE TN-1189 TB8100 VCO Out of Lock Alarms

21 June 2006

TB8100 400 to 520MHz (H1, H2 and H3 band) Reciters using RF PCB 220-02025-08.

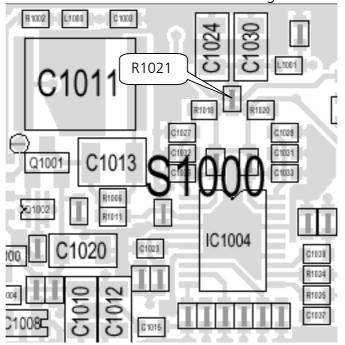
In all cases the synthesiser was actually locked and on frequency. The problem was the input voltage to the comparator that indicates an out of lock state was very close to the trigger point, just 21mV away on one of the reciters. Any noise on the DC supply or change in DC conditions with temperature will cause the comparator output to change, raising a VCO out of lock alarm.

Change R1021 and R1124 from 100 Ohms to 47 Ohms. Tait part 038-12470-00, RES 0603 47R 5% 1/10W.

Locate R1021in the RX VCO and change to 47 Ohms.

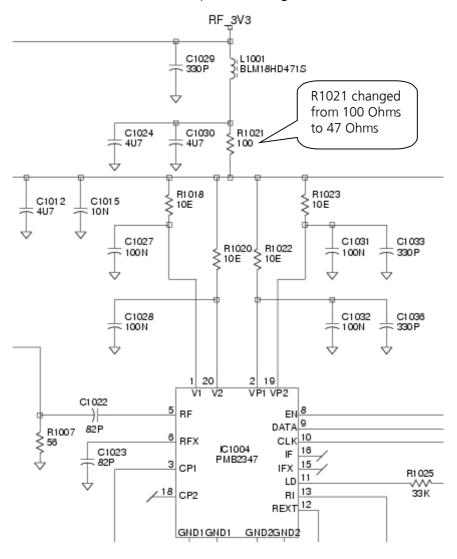
RX VCO schematic showing the location of R1021. TX VCO schematic is the same, component designations differ.
