# DGAC HF Voice/RTTY system—9114 Power Supply fails to initialise after a power failure

© 17-00194 Issue 1, January 1999

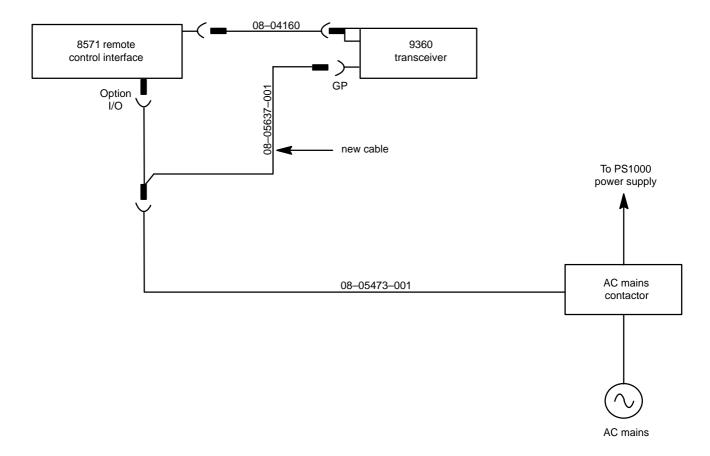
Figure 1: Wiring diagram for the AC contactor

A problem occurs after an AC mains power failure. The Codan 9114 Power Supply fails to initialise due to the low impedance of the AC mains contactor on the 12 V DC power supply line. The problem is overcome by providing switched 12 V DC power from the General Purpose (GP) port of the transceiver instead of the I/O port of the 8571 Remote Control Interface.

The Codan 9114 Power Supply fails to initialise after an AC mains power failure.

Re—route the power supply line by connecting the cable provided (part number 08–05637–001) to the GP port of the transceiver (see Figure 1).

To re—route the power supply line from the GP port of the transceiver, a special purpose cable (part number 08–05637–001) must be connected (see Figure 1). The implementation is also shown in system drawing 03–00987 Issue C.

Six cables have been sent with this Service Bulletin. Three cables, (part number 08–05637–001) are provided for the new connection, and three cables, (part number 08–05473–001) are provided to replace the cables previously modified by the customer.
