Technical Note TN-643
**Changes to T3002
Fast Charger Contacts.**

26th October 2000

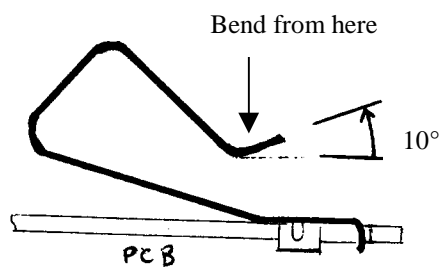
Reports from the field indicate that the T3002 charger pins are becoming bent over time. There is already a technical note in place detailing how to replace the charger contacts (TN-526), but it has been deemed necessary to develop a method of preventing the charger pins from bending at all.

Tait Mechanical engineers investigated the issue. It was reported that the end of the charger contact itself was getting snagged / caught on the gold rivet holding the charger contact in place.

The Mechanical team decided to make a modification to allow the end of the charger contact to slide over the gold rivet, thus preventing any snagging.

- Take the existing T3002 charger contact and bend (using bull nose pliers) the indicated end up by 10°.
