Technical Note TN-922-SR

Tait Orca 5010, 5015, 5020 Firmware Upgrade to 2.14 & TOP-CPA Upgrade to 4.0.1

15 October 2004

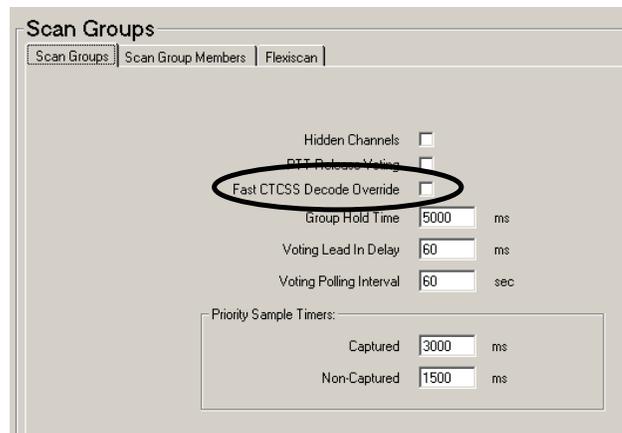
- FOCUS 16698: Under some specific scanning conditions it was occasionally possible for the CTCSS sub-audible decoder to open the radio mute upon receipt of an incorrect CTCSS sub-audible frequency. Therefore a new option has been added to the 'Scan Group' page called 'Fast CTCSS Decode Override', this is pictured below. This disables the "fast" CTCSS sub-audible decoding that is performed when the radio is in a scan group. (Raised as TIMS 30050).

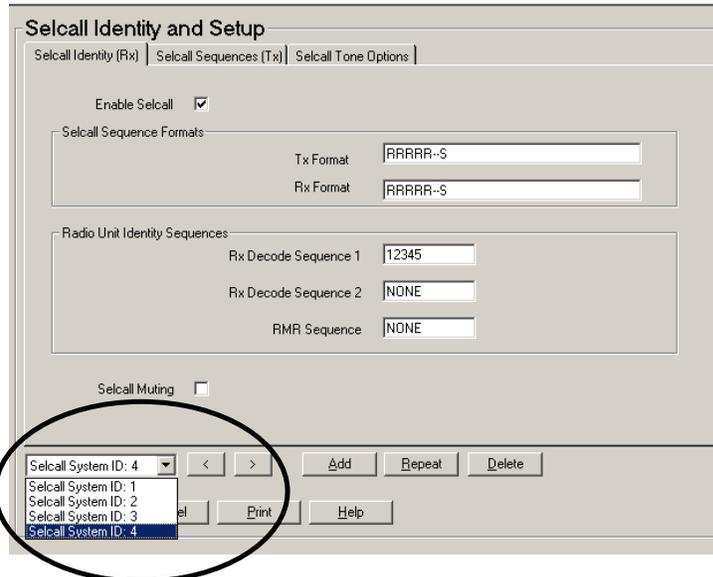
- Adding and deleting 'Selcall Systems' resulted in incorrect labelling of remaining systems. Switching between 'Selcall Systems' has now been changed to follow the TM8X00 Programming Application combo-box style. This is shown below. (Raised as TIMS 28222).
