PRODUCT ALERT

TM8200 Control Heads with missing Hardware ID String

28 November 2005

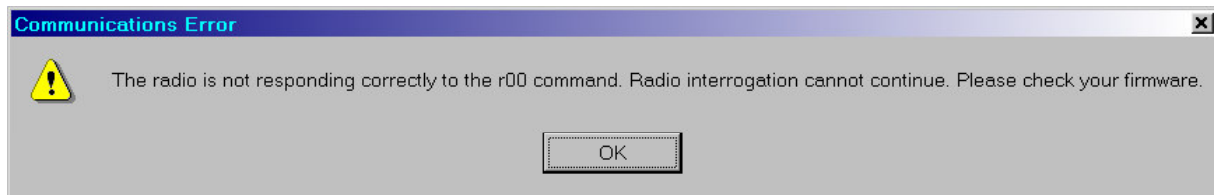
There have been shipments of TM8200 Control Heads (TMAC40-0T) that do not have the Hardware ID string correctly programmed. The user/programmer will realise this when they attempt to read or write a personality and this pop-up (below) appears.

- Source the Hardware ID String file TMAC40-0000_0004.S2
- In the TM8200 PC App click:
 - Tools > Download > Report Configuration
 - Verify the Hardware ID response is “No Code Component”
 - Click Download
 - Browse to the saved location of the Hardware ID String
 - Click Open

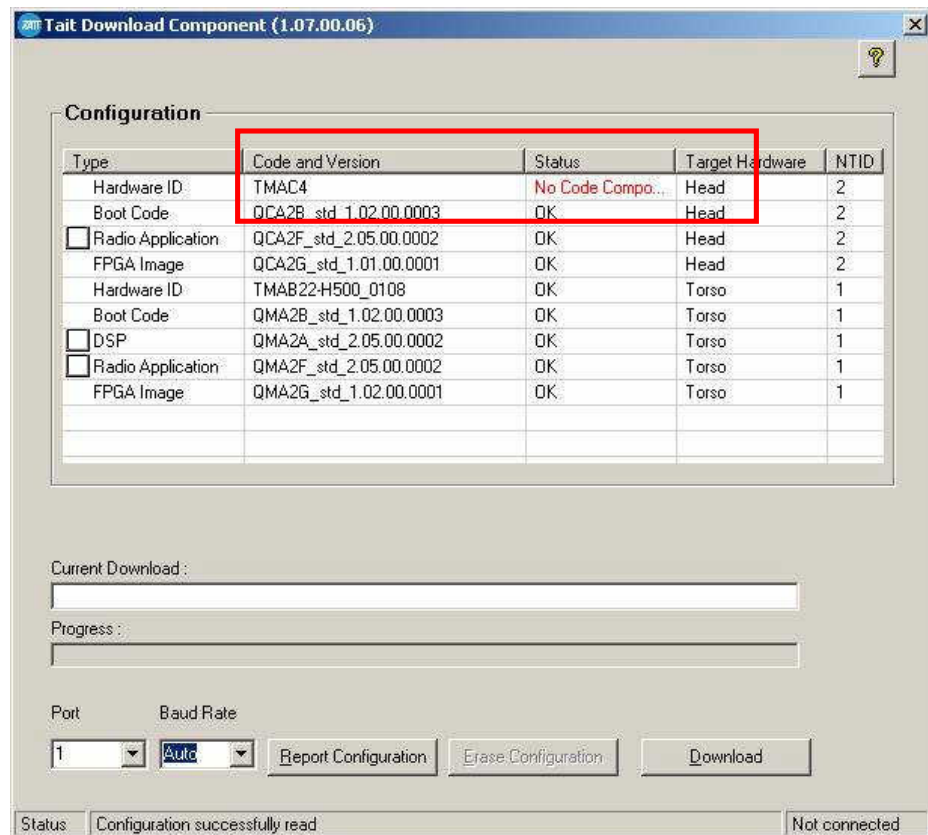
When the torso and head are interrogated using PC App: Tools > Download > Report Configuration this screenshot will display the error.

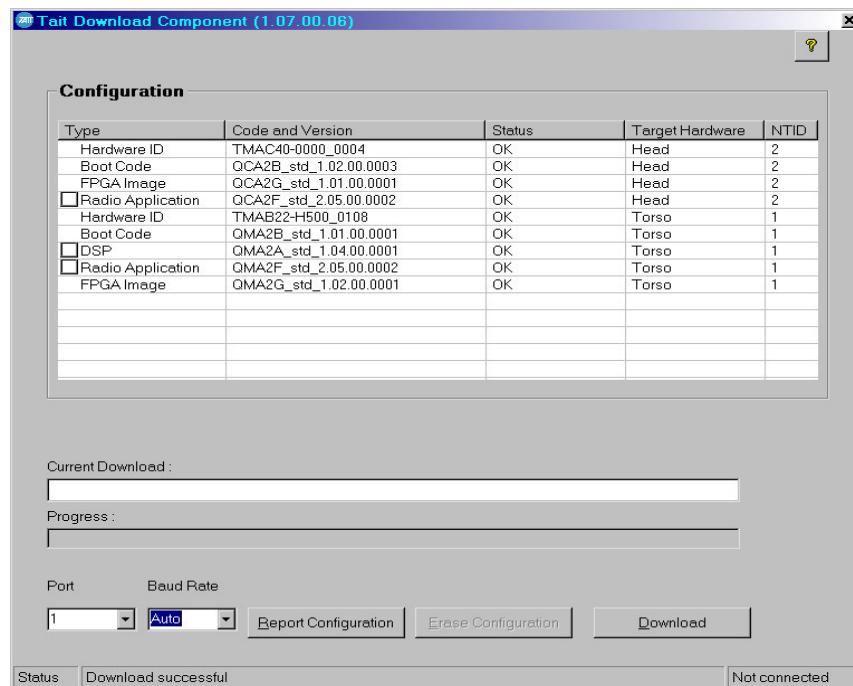
On completion of the download the display will update as per the following screenshot.
