Codan Pty Ltd
ACN 007 590 605
81 Graves Street
Newton
South Australia

9103 Automatic Antenna Tuner - Serial Nos A1312 - A1342

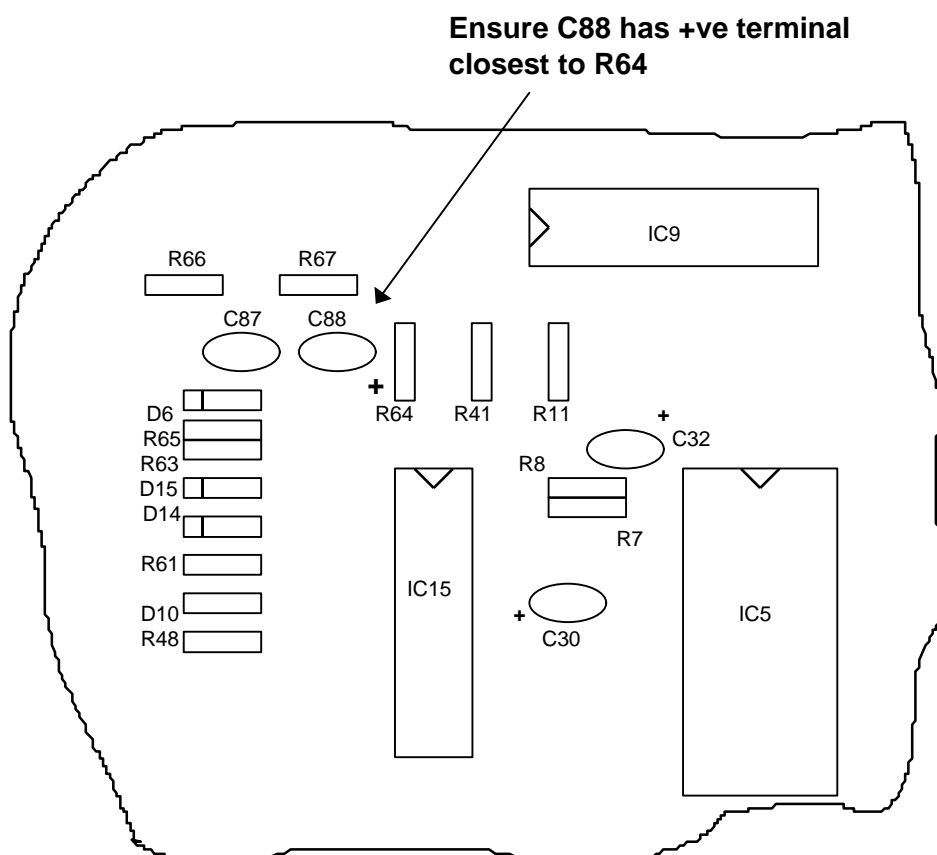
Figure 1. Part of 9103 Tuner Assembly

An error has been discovered on the PCB silkscreen whereby Capacitor C88 (2.2 μ F) may have been inserted incorrectly. The silkscreen identifies the +ve terminal of C88 closest to capacitor C87 and is incorrect. The +ve terminal should be located closest to Resistor R64.

On units with Serial Nos greater than A1342 the error has been rectified and the incorrect identifier on the PCB removed however, the possibility exists for some units in the Serial No. range A1312 - A1342 to have had the capacitor wrongly inserted. Whilst this may not be apparent from tuner operation, the capacitor may break down over a long period of time resulting in poor scan operation.

Owners of Tuners with Serial Nos in the above range are advised to check the orientation of capacitor C88 and replace it where incorrect. This can be accomplished by the following:

- I. Remove 10 screws securing the Tuner lid
- II. Remove 4 screws securing the shielding plate
- III. Check the orientation of Capacitor C88 as per the attached Fig 1 and if incorrect -
 - (a) Remove 4 screws securing the PCB, desolder Capacitor C88 and replace it with one correctly oriented.
 - (b) Carefully scratch off the + sign on the PCB adjacent to C88 to avoid future confusion;
 - (c) Replace the PCB
- IV. Re-assemble the Tuner
