Codan Pty Ltd
ACN 007 590 605
81 Graves Street
Newton
South Australia

Enhancements in 9323 Series Transceivers

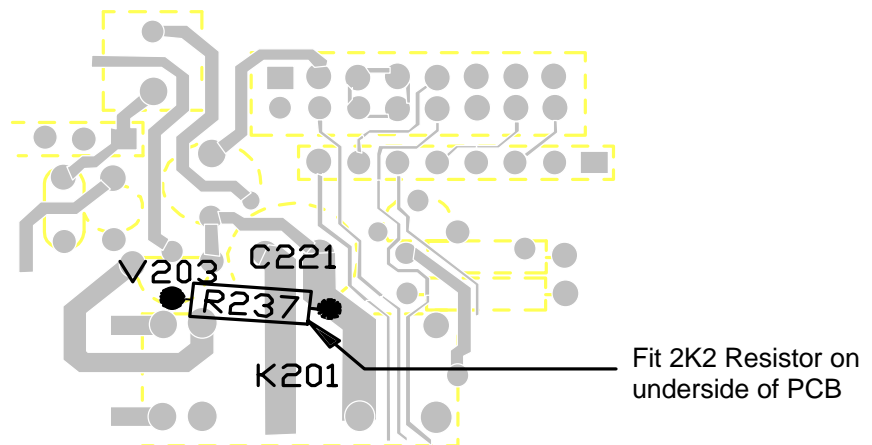
08-04966-001
Bottom View

2. Transceiver turns itself ON and/or unable to turn transceiver OFF

The transceiver turns itself ON and then may or may not be able to be turned OFF. This is caused by leakage in the power-on circuit and can be overcome by biasing V203 (the power-on transistor) off slightly so that it requires a greater base current to turn the transceiver ON.

The remedy requires the addition of a resistor on the Microprocessor & Audio PCB assembly, 08-04966-001. With the transceiver disconnected and removed from the installation, remove the bottom cover. Disconnect all the ribbon cables from the PCB taking careful note of the orientation of the connectors on P103 and P302. Remove the 7 cross head screws securing the PCB in place and withdraw the PCB. Identify V203, which is located at the right rear corner of the PCB (with the front panel towards you) adjacent to the relay K201. Fit a 2K2 resistor between the Base of V203 and relay K201, (Base-Emitter junction of V203), as shown below. This resistor can be added to any circuit diagrams that you may have, and be designated R237.
