Loss of Configuration Information (Serial Data) in 9323/9360/9390 series transceivers.

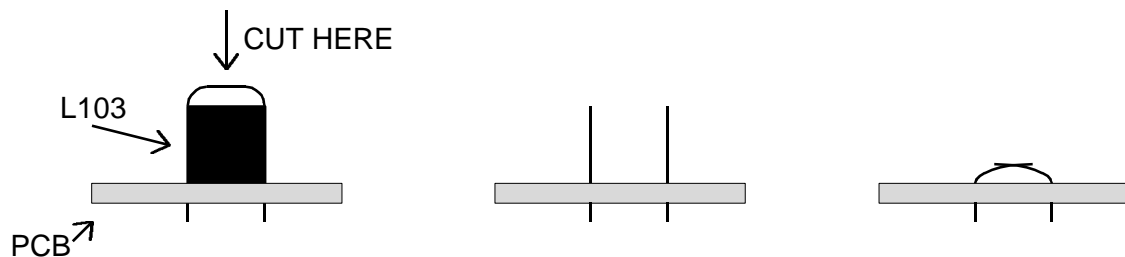
This Service Bulletin refers to the *possible* loss of configuration information in the 9323/9360/9390 series transceivers.

Remove L103, a choke located on the Microprocessor & Audio PCB, 08-04966.

1. Remove the transceiver from the installation, ensure the power is disconnected.
2. Remove the two screws securing the bottom cover and remove the cover.
3. Locate the Microprocessor and Audio PCB Assembly (08-04966-001).
4. Remove the 4 screws securing the top Microprocessor (μ P) shield. Remove the shield.
5. Locate L103, a ferrite bead inductor located adjacent to IC 101.
6. Using a pair of side cutters, cut the ferrite bead and the wire simultaneously. Remove the ferrite by sliding it up and off the wires. Ensure all traces of ferrite are removed from the PCB.

7. Bend the two wires towards each other so that they are flat on the PCB.
8. Trim off excess wire and solder the two wires together to form a link.
9. Replace the top μ P shield and secure with the 4 screws.
10. Replace the bottom cover and the 2 securing screws.
