## Receiver Desensitisation in 9323 & 9360 Transceivers

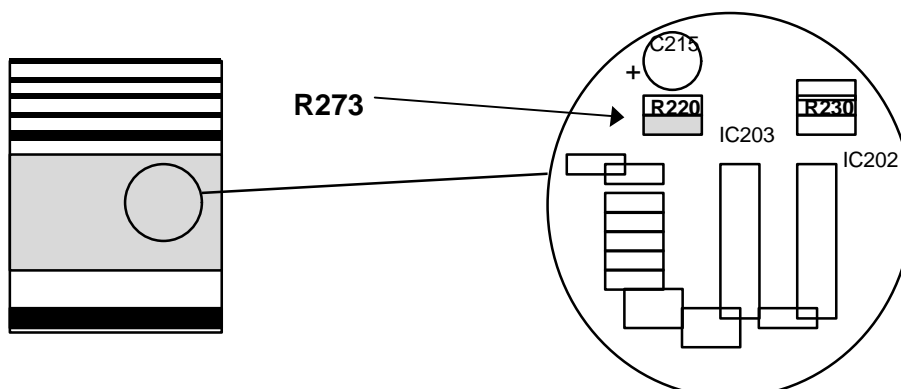
Figure 1 Location of R273

The introduction of Version 3 software redefined the use of the I/O (Input/Output) ports of IC209 on the Receiver/Exciter PCB (P/No 08-04962-001) within the transceiver. This change produced an effective desensitisation of the receiver of some 10dB. To overcome this, the line from Port 3 of IC209 (Pin 7) should be disconnected. This is best achieved by the removal of resistor R273. Once removed you should note an improvement in receiver performance. Transceivers factory fitted with Version 3 or later software already incorporate this modification.

1. Remove the transceiver top cover.
2. Locate the Receiver/Exciter PCB, part number 08-04962-001.
3. With the front panel towards you, locate R273 (100K ohm resistor).

4. Remove R273 from the PCB by carefully cutting both leads with a pair of side cutters.
5. Replace the transceiver top cover.
