DOCUMENT NUMBER: 17-00169  
ISSUE NUMBER: 1  
ISSUE DATE: August, 97

## 8525B/8528/9313/9480 - Erroneous Power up

This Service Bulletin refers to 8525B/8528/9313/9480 series transceivers that power up of their own accord.

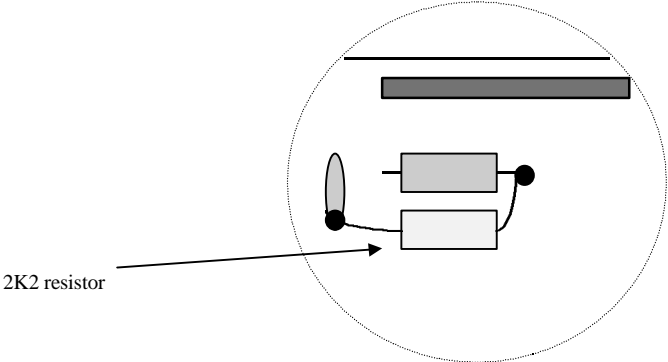
Figure 3. Location of 2K2 resistor

The cause is a small leakage current in the Power On circuit via the switch substrate. This leakage current is sufficient to forward bias V2 (the Power On transistor) hence energising K2 and turning the radio ON.

The problem can be corrected by applying some reverse bias to V2 negating the effect of the leakage current. This is done by installing a 2K2 ohm resistor between the Base and Emitter of V2.

- 7.6 Solder the 2K2 resistor to R12 and C11 as shown in Figure 3.
- 7.7 Refit the Microprocessor Assembly. (Ensure that two adjacent connector pins do not go into the same socket.)
- 7.8 Refit the bottom cover.
- 7.9 Reinstall the transceiver.
