DOCUMENT NUMBER: 17-00170  
ISSUE NUMBER: 1  
ISSUE DATE: August, 97

## Corruption of 9002 Self Address

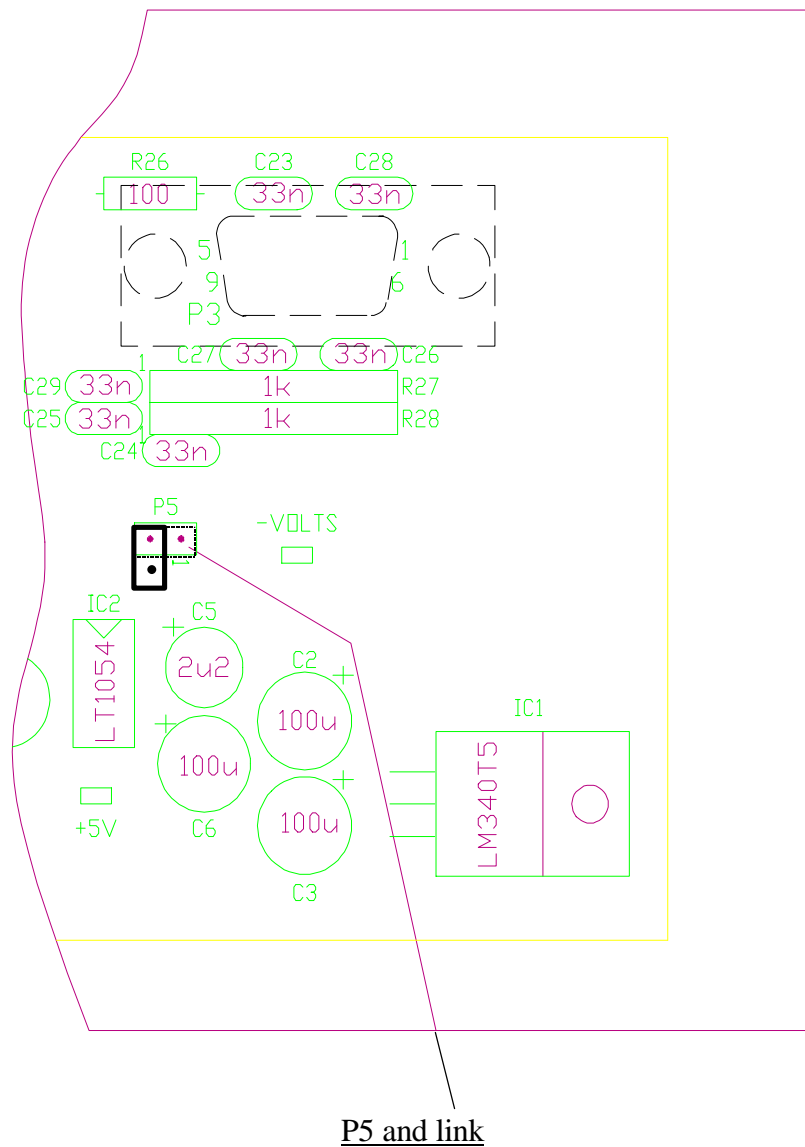
9002 Data Modem resets when 9102 Software exits. This can cause corruption of the Modem's Self Address.

Figure 1 Position of Link on P5. Rotate link through 90°

Units dispatched prior to this can be modified by simply repositioning a shorting link on the User Connector PCB assembly.

1. Ensure power is disconnected from the 9002.
2. Remove the two screws securing the top cover.
3. Remove top cover.
4. Locate the User Connector PCB. This is at the rear of the chassis.
5. Locate P5. Refer Figure 1. (P5 will have a black shorting link fitted.)
6. Carefully remove the link by grasping it with forefinger and thumb and pulling it from P5. Alternatively use a small pair of pliers or tweezers.
7. Rotate the link through 90° and refit it to EITHER pin of P5. Refer Figure 1.
8. Replace the top cover.
9. Refit the screws.
10. Reinstall the modem.
