DOCUMENT NUMBER: 17-00173
ISSUE NUMBER: 1
ISSUE DATE: September, '97

Failure of 8580 to establish link OR very slow data transfer

This Service Bulletin refers to Codan 8580 modems used with a 9323/9360/9390/9780 transceiver.

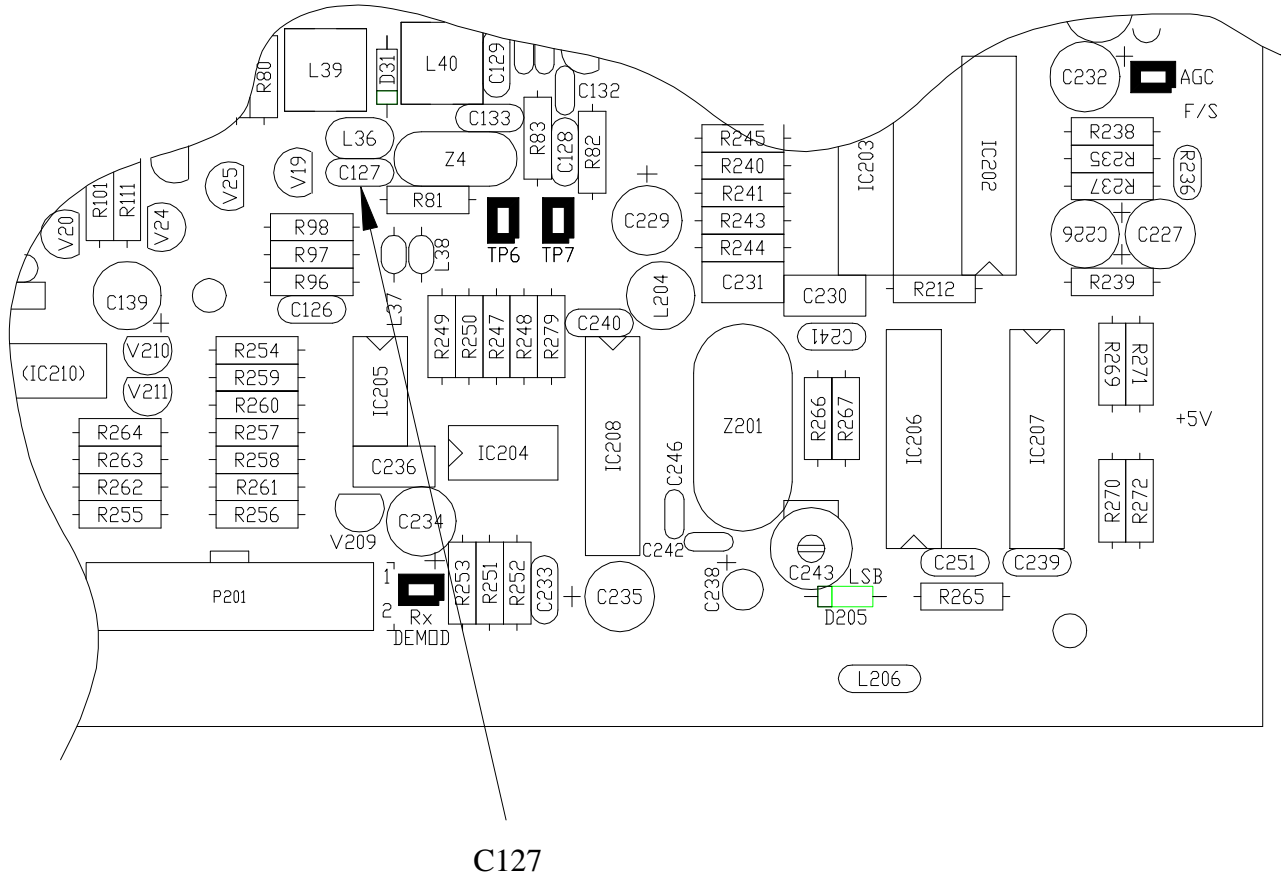
Figure 1: Portion of Receiver/Exciter PCB

The fault is related to VCO2 within the transceiver. It may only occur intermittently.

The modification involves the changing of a capacitor value on the Receiver/Exciter Printed Circuit Board (PCB), part number 08-05322-001 or 002.

1. Remove the transceiver from the installation.
2. Remove the top cover.
3. Disconnect the three plugs connected to the Receiver/Exciter PCB.
4. Remove the seven screws securing the PCB.
5. Withdraw the PCB from the chassis.
1. Locate C127, 33 nF. Refer Figure 1.

2. Using the appropriate desoldering tool, remove C127 from the PCB.
3. Replace C127 with a 220 pF capacitor.
4. Fit and secure the PCB into the chassis with the seven screws.
5. Refit the plugs ensuring the lead with the red identification (P502) connects to J2 (the connector closest to the large VCO1 can).
6. Fit the top cover and secure.
7. Reinstall the transceiver.
8. Connect power.
