DOCUMENT NUMBER: 17-00176
ISSUE NUMBER: 1
ISSUE DATE: November, '96

VCO1 Unlock in 9323 & 9360 series transceivers

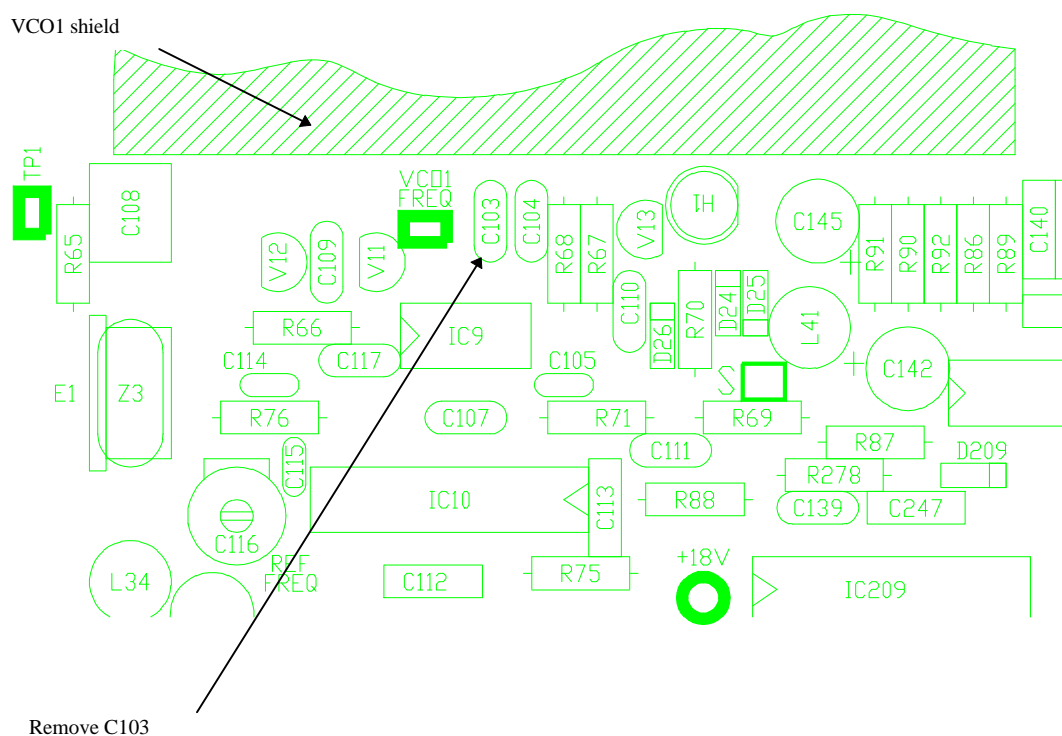
Figure 1. Location of C103

- Remove the transceiver from the installation.
- Remove the two screws securing the top cover.
- Locate the Receiver Exciter Printed Circuit Board (PCB), 08-04962.
- Disconnect all the connectors from the PCB.
- Remove the seven screws securing the PCB.
- Withdraw the PCB from the chassis.
- Locate and remove C103 from the PCB. Refer to Figure 1.
