DOCUMENT NUMBER: 17-00180
 ISSUE NUMBER: 2
 ISSUE DATE: March, '98

Transceiver fails to power up normally

This Service Bulletin refers to front control transceivers and control heads dispatched since December 1997. This is the second issue of this Service Bulletin in which the range of acceptable regulators has been extended.

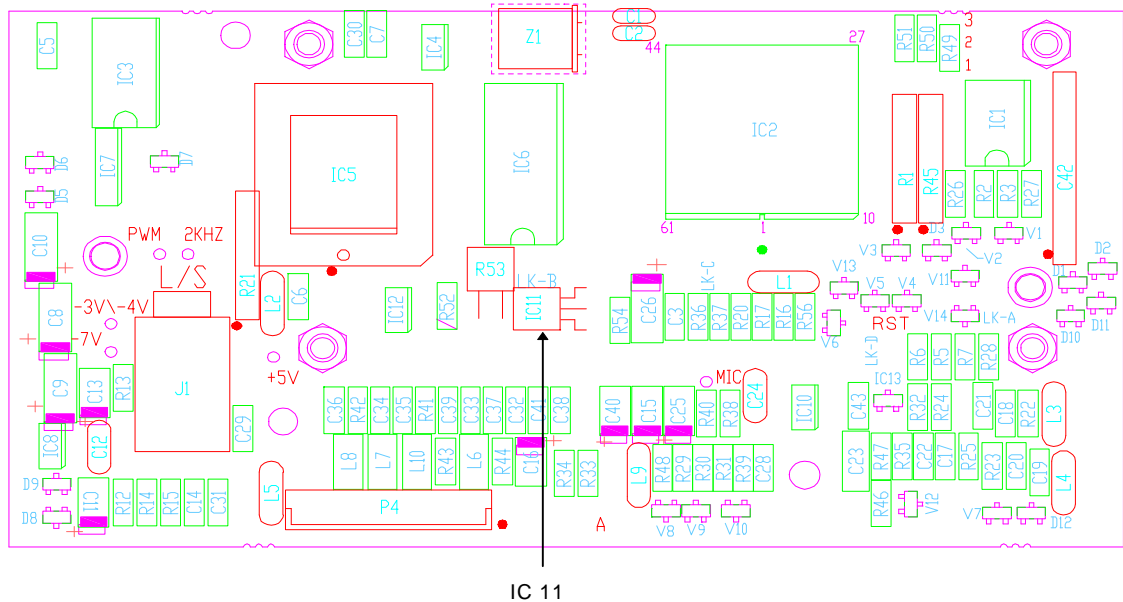
Figure 1: Location of IC11

The problems are caused by the use of non brand-name, generic voltage regulators.

A recent change to the microprocessor reset circuit (refer Service Bulletin 17-00175), has made the use of non brand-name generic regulator types unacceptable.

- ❑ Carefully lift IC11 up off the board so that the identifying markings on its flat side may be read.
- ❑ Check that the regulator has a manufacturer's marking such as a **trademark** or a **name**.
- ❑ If IC11 does not have a manufacturer's trademark or name it will need replacing. Continue at *Procedure: changing the regulator*.
Otherwise, continue at *Reassembly*.

- ❑ Insert the regulator into the three holes. *Flat side down*. Refer to Figure 1.
- ❑ Solder the three leads into the display board.
