DOCUMENT NUMBER: 17-00181
ISSUE NUMBER: 1
ISSUE DATE: February, '98

Ripple or oscillations on 8571 'B' rail

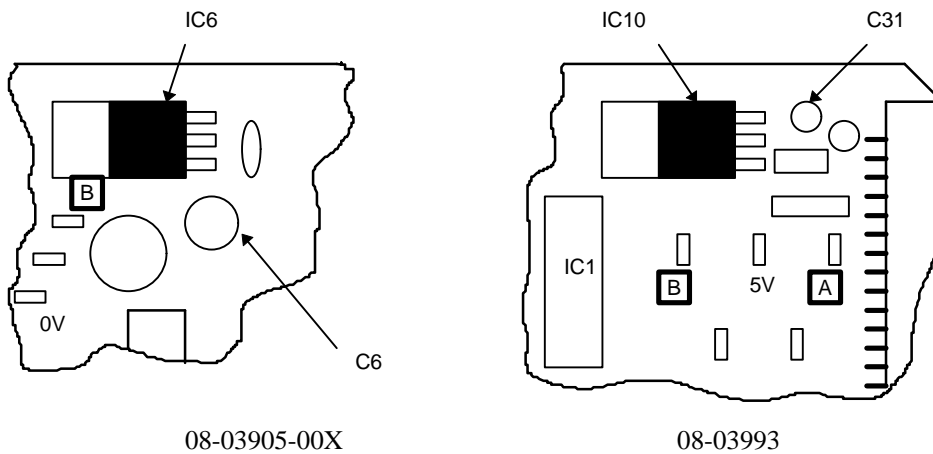
Figure 2. Location of C6 and C31

The cause is insufficient capacitance on the output of the 10 volt regulators which provide the 'B' rail of both the Microprocessor and Transceiver Interface PCB (08-03993) and the Dual Line Equaliser PCB (08-03905-00X).

The value of the capacitors on the 'B' rail of all identified PCBs should be changed to 10 μ F.

- ❑ Referring to the part numbers printed on the PCBs, locate the relevant capacitors:
On the 08-03095-00X PCB, locate C6. Refer to Figure 2.
On the 08-03993 PCB, locate C31. Refer to Figure 2.

- ❑ Remove C6 and C31 and replace them with 10 μ F capacitors.
- ❑ Reinstall the PCBs ensuring they go in the correct positions. Refer to Figure 1.
