CODAN

Unreliable communication of the 8570 Remote Control Console

Head Office	© 17-00183 Issue 2, August 1999	Page 1 of 4	
Codan Pty Ltd ACN 007 590 605 81 Graves Street Newton South Australia 5074 Telephone +61 8 8305 0311 Facsimile +61 8 8305 0411	Codan (UK) Ltd Gostrey House Union Road Farnham, Surrey GU9 7PT United Kingdom Telephone +44 1252 717 272 Facsimile +44 1252 717 337	Codan Pty Ltd Suite 11A, 2 Hardy Street South Perth Western Australia 6151 Telephone +61 8 9368 5282 Facsimile +61 8 9368 5283	Codan Comunicaciones Ltda. Av. 11 de Septiembre 2155, Of. 701/A Edificio Panorámico Providencia Santiago, CHILE Teléfono +56 2 373 9577 Facsimile +56 2 373 9579

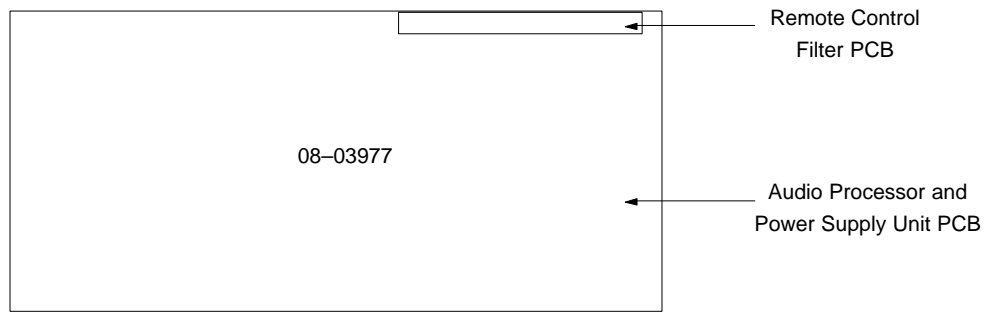
Figure 1: Location of Remote Control Filter PCB on the Audio Processor and Power Supply Unit PCB

The Remote Control Filter PCB is the small PCB mounted upright in the right-hand corner of the Audio Processor and Power Supply Unit PCB (see Figure 1).

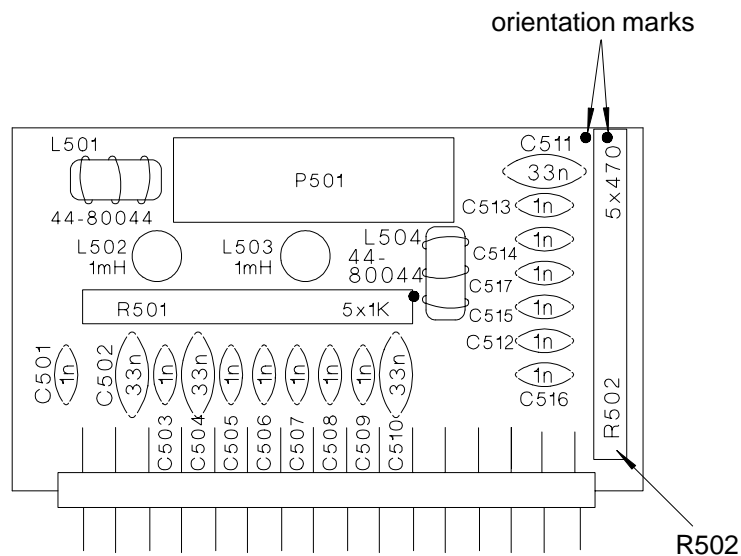
Figure 2: Location and orientation of R502 on the Remote Control Filter PCB

The unreliable communication of the 8570 is caused by excessive series resistance of the resistor pack R502 (part number 40–83101–500) on the Remote Control Filter PCB. This causes loading of the I²C Clock and Data lines.

- Locate R502 on the Remote Control Filter PCB (see Figure 2).

If the resistance is $\approx 1 \text{ k}\Omega$, then the resistor pack R502 needs replacing.

- Desolder and remove R502.
- Observing the correct orientation, fit the replacement resistor pack (part number 40-82471-500) in the position that R502 occupied.
