# 9323/9360 software and hardware upgrade for morse code

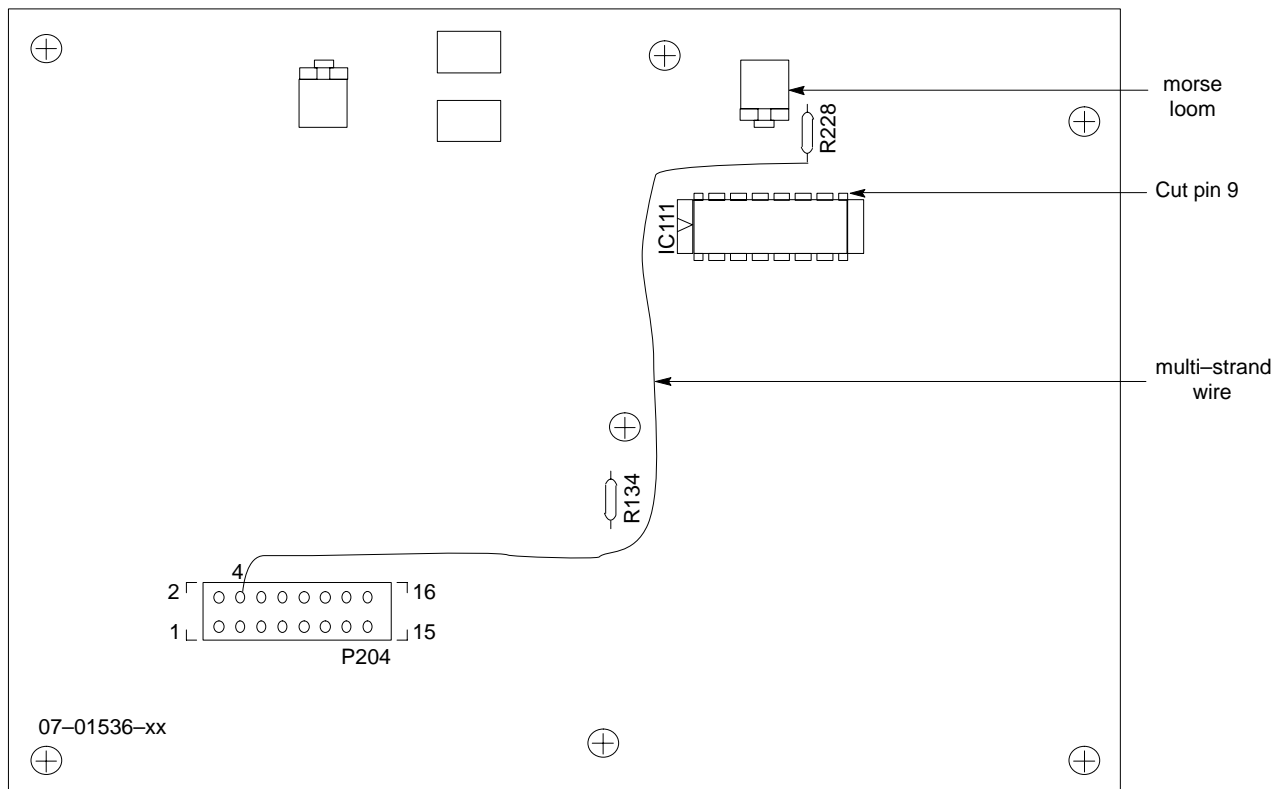
The switching speed of the transceiver is too slow causing high speed morse transmissions to sound irregular.

Figure 1: Hardware modification to the Microprocessor and Audio PCB (07-01536-11)

- Switch the power off.
- From the component side of the Microprocessor and Audio PCB (assembly part number 08-04966, PCB part number 07-01536-11), cut pin 9 of IC111 using side cutters (see Figure 1).

Ensure there is no connection between pin 9 of IC111 and R228 through visual examination or using an ohm-meter.

- Route the multi-strand wire (part number 66-02072-005) from R228 to pin 4 of P204 (see Figure 1).
