CODAN

Y2k compliance upgrade for the Fax and Data Interface 9001

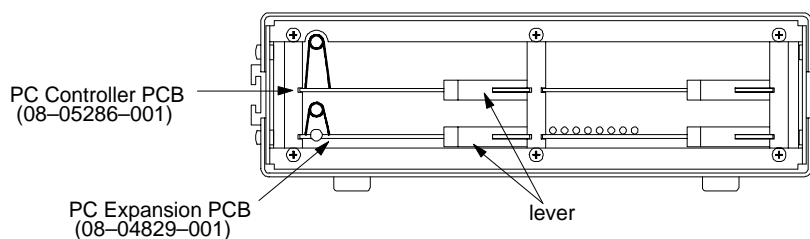
Figure 1: Position of the PC Controller PCB and the PC Expansion PCB in the 9001

- Locate the slot containing the PC Controller PCB at the top left-hand corner of the interface (see Figure 1).
- Pull the lever forward and remove the PC Controller PCB.
- Check the part number of the PC Controller PCB.

- Locate the slot containing the PC Expansion PCB at the bottom left-hand corner of the interface (see Figure 1).
- Pull the lever forward and remove the PC Expansion PCB (part number 08-04829-001).

- If you have removed the PC Expansion PCB, replace it in the slot at the bottom left-hand corner of the 9001 (see Figure 1).
- If you have removed the PC Controller PCB, replace it in the slot at the top left-hand corner of the 9001 (see Figure 1).
- Replace the front panel of the 9001 and secure it into position with the four securing screws.

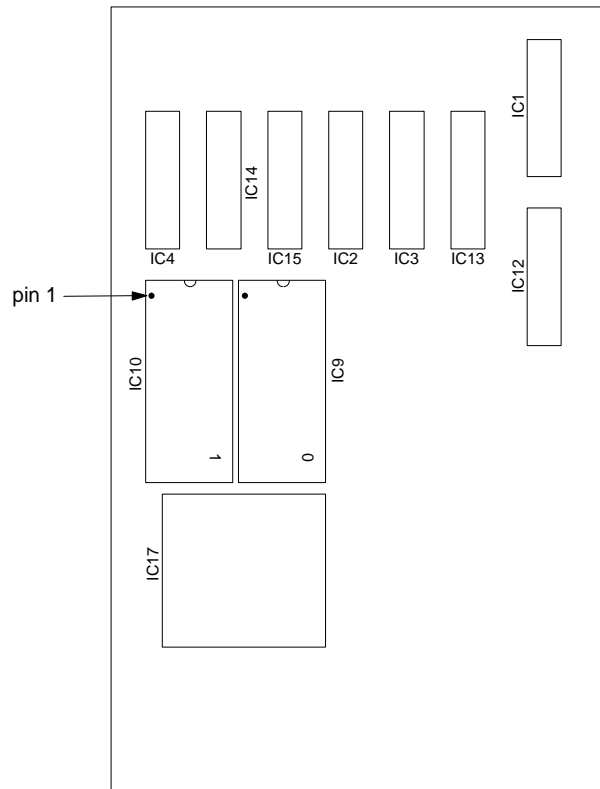
Figure 2: PC Expansion PCB

- Locate IC9 and IC10 on the PC Expansion PCB (see Figure 2).

- Check the software version on the label of IC9 and IC10.

If the software version is less than 2.52, the software must be upgraded. Contact Codan for the new software (part number 90-20527-001).

- Note the orientation of IC9 and IC10 and remove them from the PC Expansion PCB.
- Correctly orientate and fit the EPROM, labelled **0**, in the position that IC9 occupied.
- Correctly orientate and fit the EPROM, labelled **1**, in the position that IC10 occupied.
