CODAN

Design fault in the DSP Modem PCB in the 9001 Fax & Data Interface

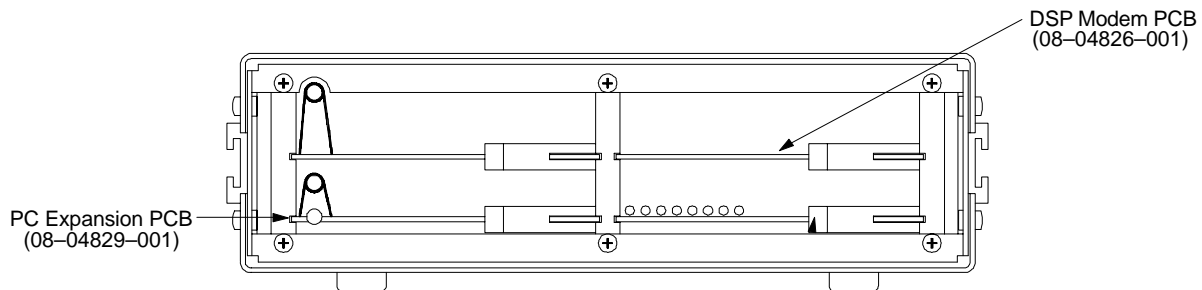
Figure 1: Position of the DSP Modem PCB in the 9001

The ferrite creates a 1 kΩ resistance to ground through the clip holding the two ferrites together. This creates a parallel port interrupt on the PC Expansion PCB (see Figure 1). This activity on the PC Expansion PCB initiates a “BUSY” response in the 9001, which responds as if it is printing. The most common cause of this problem is solder in the via running underneath T1.

- Switch the power off to the 9001.
- Remove the front panel of the 9001 by removing the four securing screws.
- Locate the slot containing the DSP Modem PCB at the top right-hand corner of the interface (see Figure 1).
- Pull the lever forward and remove the DSP Modem PCB (part number 08-04826-001).

- Replace the DSP Modem PCB in the slot at the top right-hand corner of the 9001 (see Figure 1).
- Replace the front panel of the 9001 and secure it into position with the four securing screws.
- Switch on the 9001 and try sending a text or binary file using 9102 Fax & Data Controller software.
 - ↪ If the 9001 begins sending the text or binary file, the problem has been rectified.

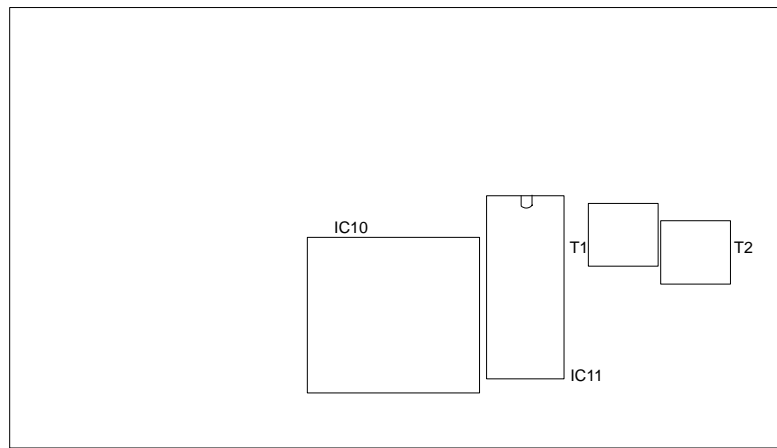
Figure 2: DSP Modem PCB

The “-ACK line” of the 9001 Fax & Data Interface is being held low as it passes through a via (a through-hole connection between the tracks on either side of the PCB). The via is shorting to the ferrite of T1.

The via has a track between pins 27 and 26 of IC11.

To correct the problem, the solder in the via running underneath T1 on the DSP Modem PCB must be removed. To access the via, T1 must be removed.

- Desolder T1 from the DSP Modem PCB (see Figure 2).

- Locate the via, which runs directly underneath T1 (see Figure 2).

- Remove the solder with a solder wick.
 - ↪ Check that there are no sharp pieces of solder protruding from the via.
- Place a piece of insulating tape over the via.
 - ↪ Ensure that the via is completely covered by the tape.
- Resolder T1 to the DSP Modem PCB.
