TECHNICAL NOTE TN-1015

Problems with IC306 used in TBA10C0 (TB8100 Isolated E&M SIF)

6 May 2005

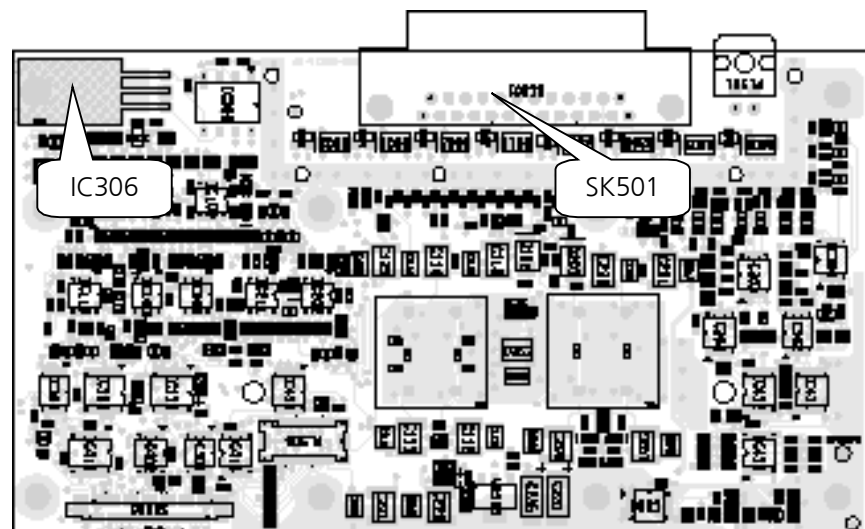
Location of IC306 on the SIF.

This layout drawing of the SIF shows the location of IC306. It may be necessary to remove the end plate to see the device clearly.

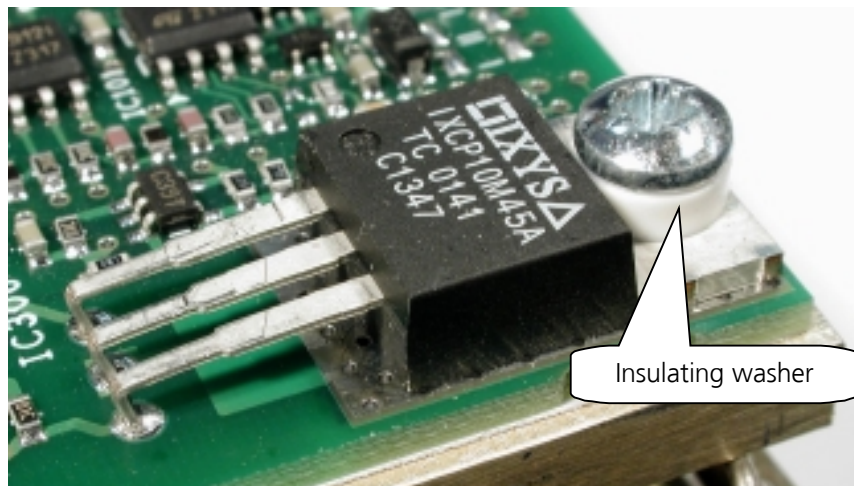
The device has its part number clearly marked as IXCP10M45A. It should have a plastic insulating washer under the screw holding the device down but does not have an insulator between the device and the PCB. This part of the PCB is isolated from ground.

IC306 with insulating washer fitted and the correct part number. Note there is no insulating washer under the device.
