Technical Note TN-697

## Tait Orca Accessory modification update

28<sup>th</sup> February 2002

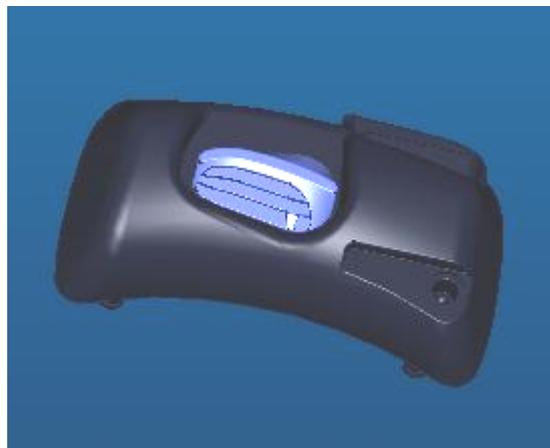
A vertical rib on the thumb grip of the accessory latch identifies the hardened plastic version of the new accessory.

See attached picture with the modified thumb grip highlighted in blue for distinction.

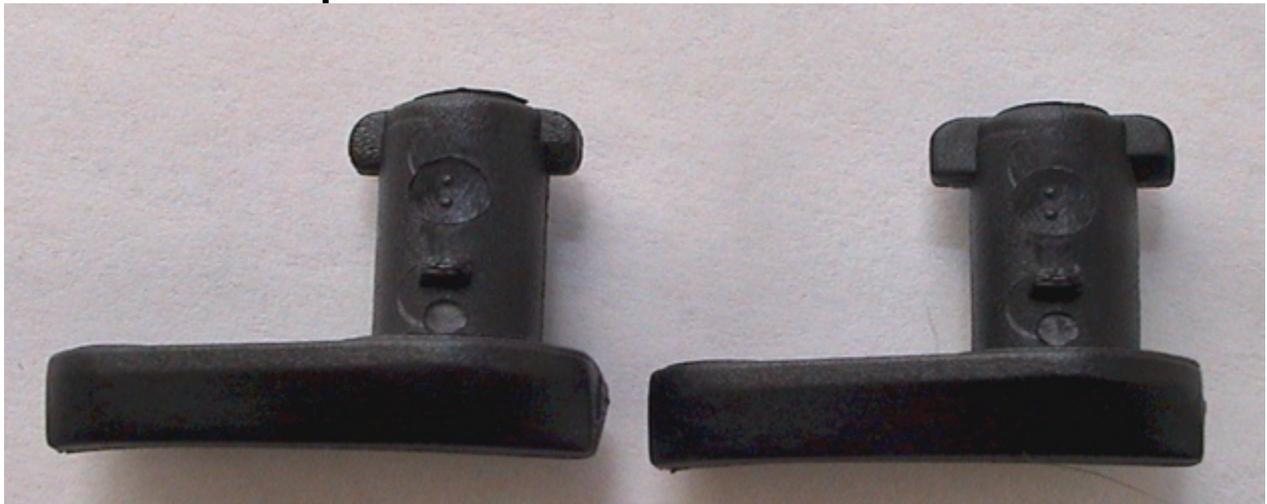
### 3. Side Views of the P-Clip

Side view of the old P-Clip

Side View of the new P-Clip  
Note the Lug size and shape

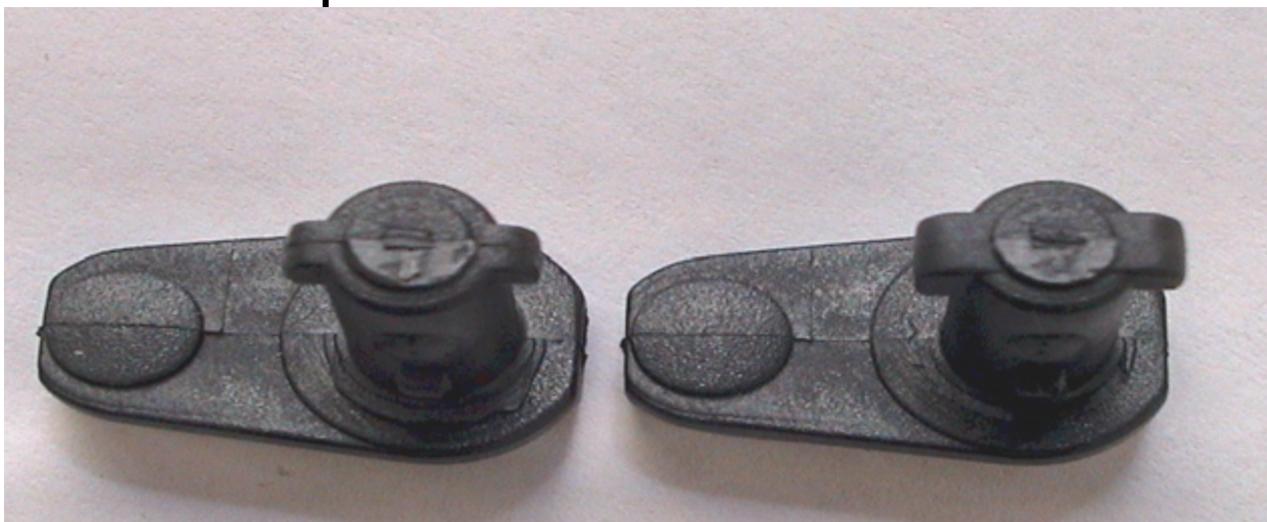
### 4. Top views of the P-Clip

Top view of the old P-Clip

Top View of the new P-Clip  
Showing the lug width

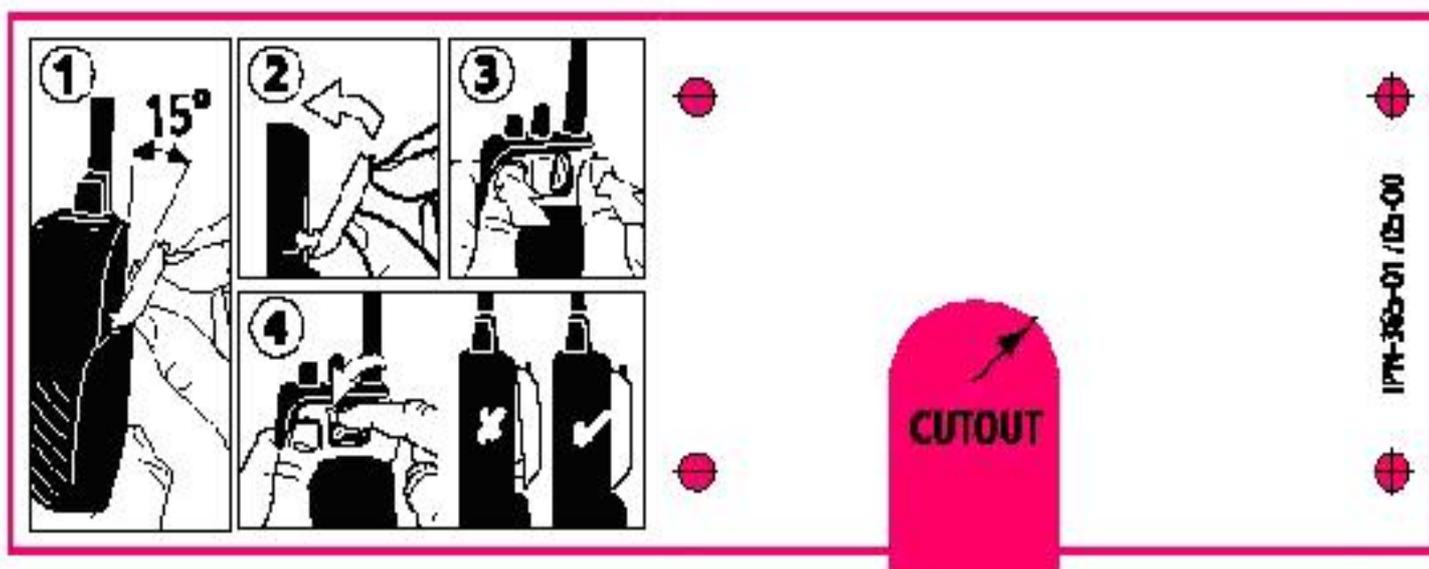
To mount the Tait Orca accessory connector on to the radios the locating pins at the lowest corners of the accessories should be inserted, first with the accessory at 15°, then folded flat against the radio and the accessory locked.

The diagram below will be supplied, wrapped around every new accessory connector from the date of this Technical Note.
