TECHNICAL NOTE TN-1137-SR

TM9155, TP9155, TP9160 Subscriber Unit Firmware Upgrade to v2.04.00.0002

22nd December 2005

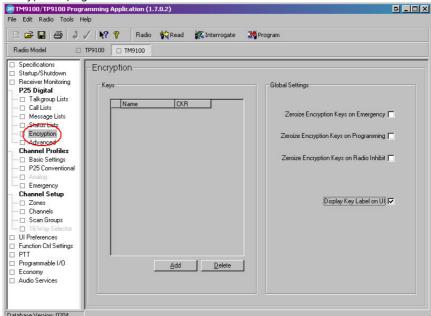
There are two areas in the XPA that deals with Encryption. The first is the Encryption page.

For a full explanation of the Encryption pages please refer to the Online Help in the programming application, the Encryption Key Loading Guide which can be found on the Taitworld support website (www.taitworld.com/support) or contact Technical Support.

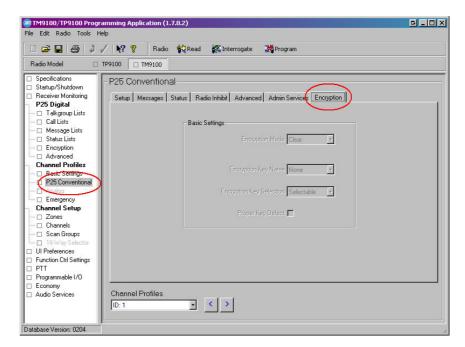
The second area is the Encryption tab on the P25 Conventional page.
