Figure 4.1 T858/859 Test Break Point Location

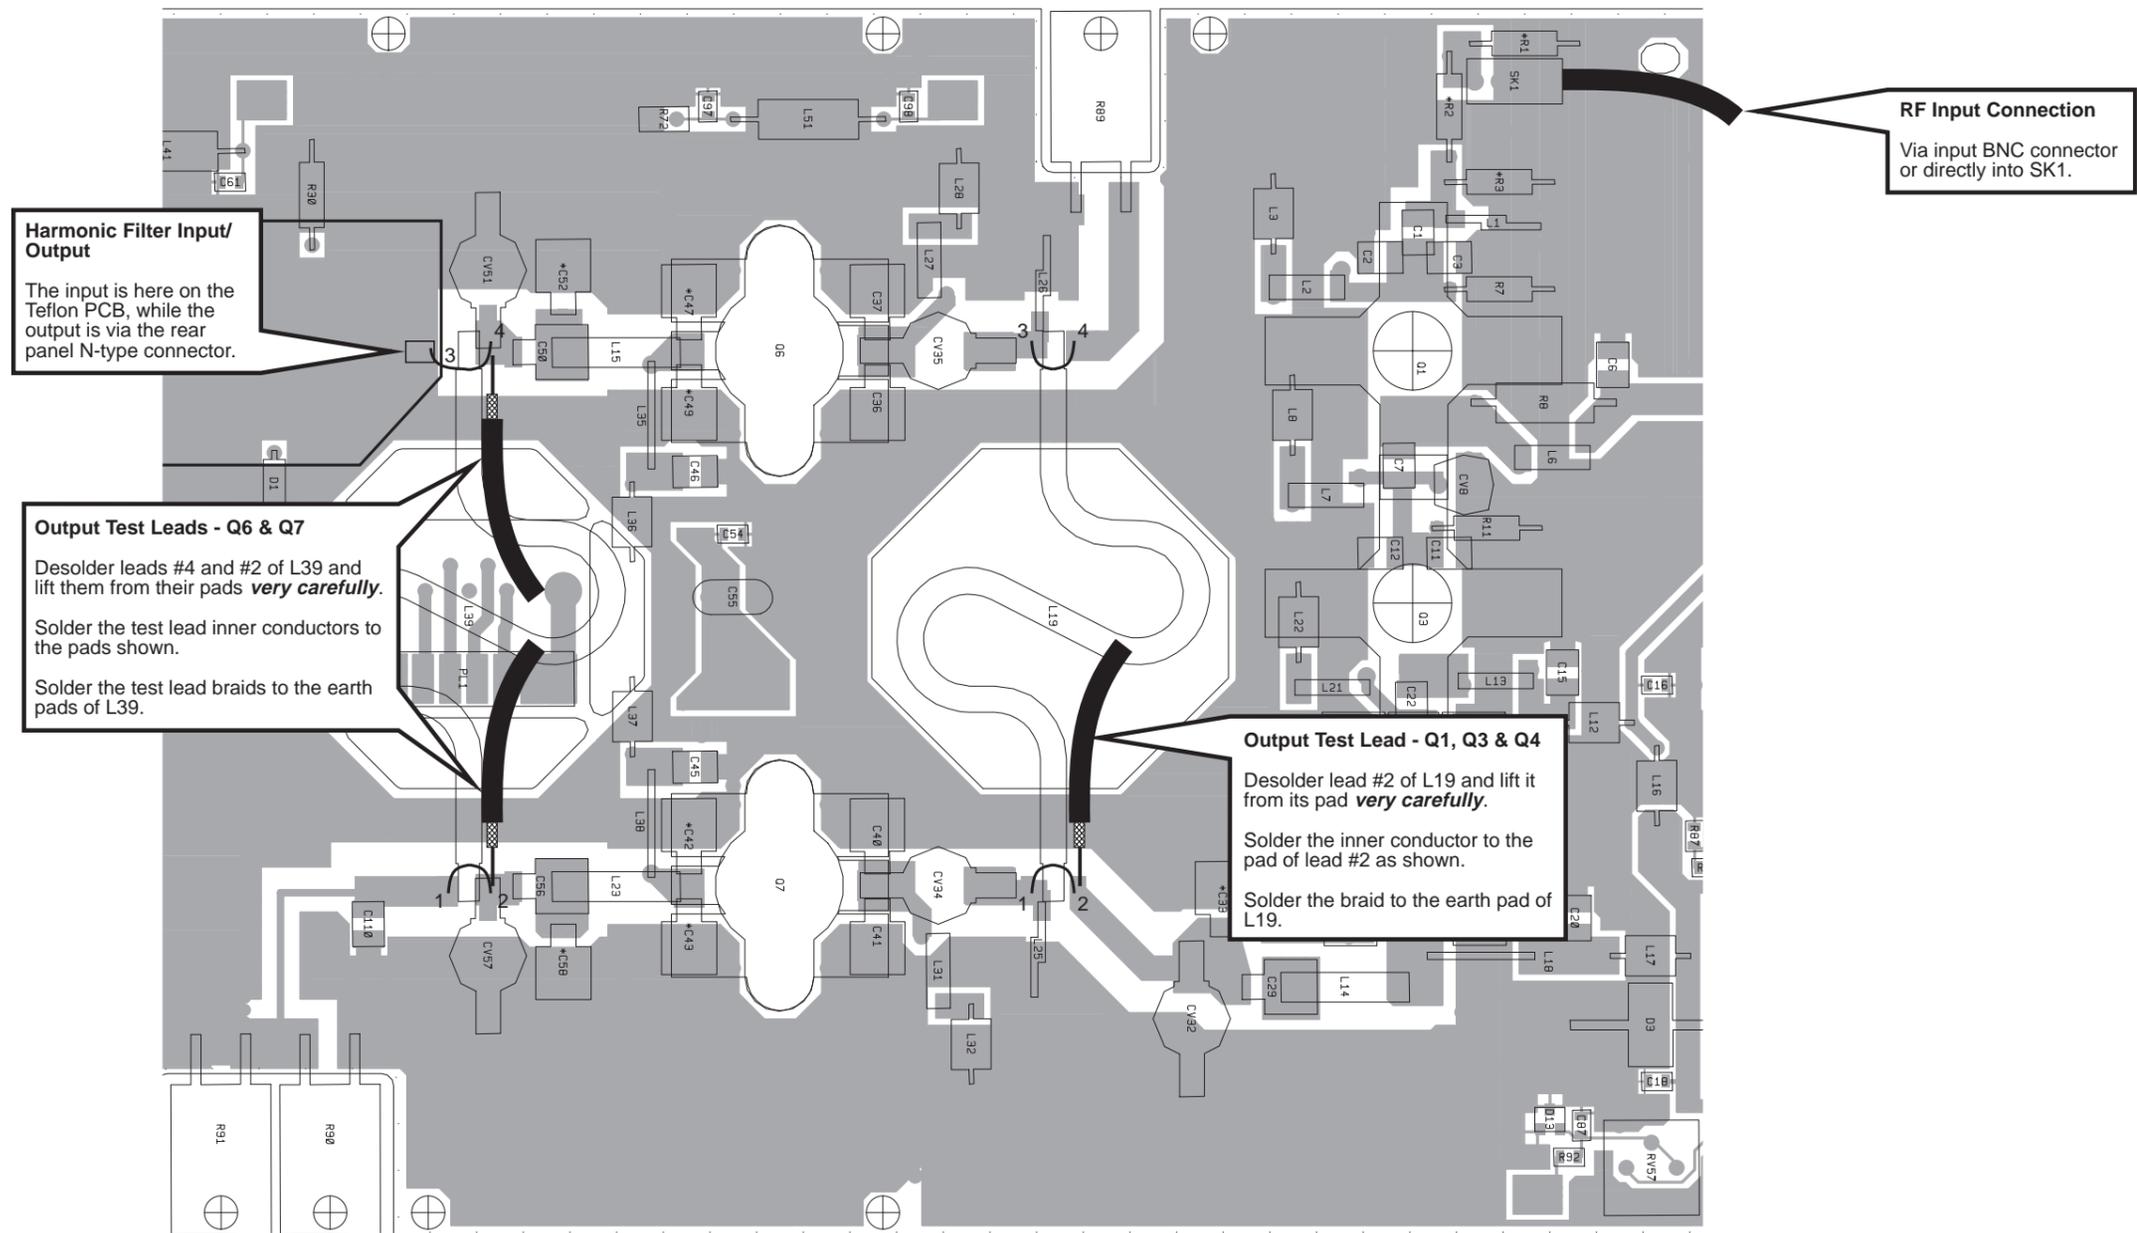
Caution: L19/L39 Inner Conductors

The inner conductors of L19 and L39 are silver wire and are very fragile. Take care not to damage them when desoldering and lifting them off the pads.

When resoldering, make sure each inner conductor curves onto the pad (as shown in the drawing) to protect it from thermal stress or shorts. Do not pull the wire tight.
